CHANGE IN THE DIFFERENTIAL PINION THRUST WASHERS

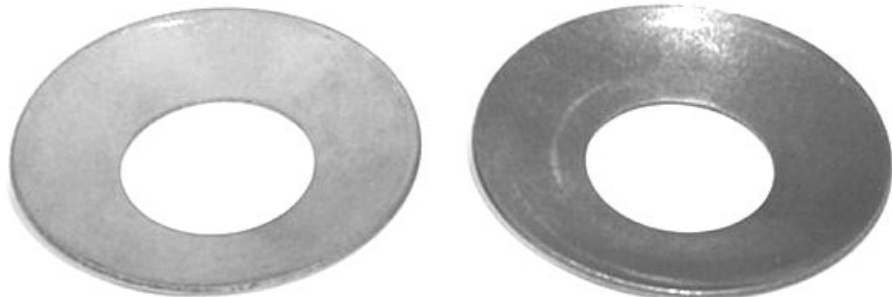
- 1. Change:** The heat treatment in the differential pinion thrust washers has been changed. The surfaces are now nitrated.
- 2. Cause of Change:** To increase the service life of the pinion thrust washers.
- 3. Identifying:** The new nitrated thrust washers are light gray and more mat finished looking than the old washers.
Part numbers have not been changed.

- 5. Date of Change:** Installing of the new thrust washers has started in the beginning of the year 2004 in axle production. From that point of time the new thrust washers have replaced the older ones also in the spare parts deliveries.
- 6. Interchangeability:** The new thrust washers are totally interchangeable with the old thrust washers in spare parts use.
- 7. Spare Parts:** We recommend that only the new type of thrust washers will be used as service parts. Old service part stock items can be returned to us and we will supply replacing new parts.
- 8. Photos:** The new thrust washer on the left and the old washer on the right. Compared to the photo the thrust washers can be slightly darker or lighter depending of the manufacturing patch.
