CHANGE IN THE INPUT AND OUTPUT DRIVE FLANGE SEALING IN THE 10/11 TON THROUGH DRIVE AXLES

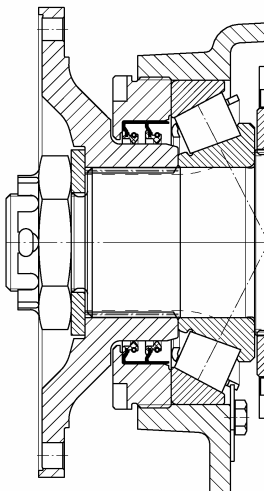
Picture 1. Earlier design of the input flange sealing.

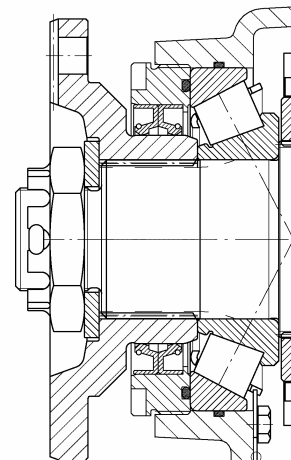
Picture 2. Current design of the input flange sealing.

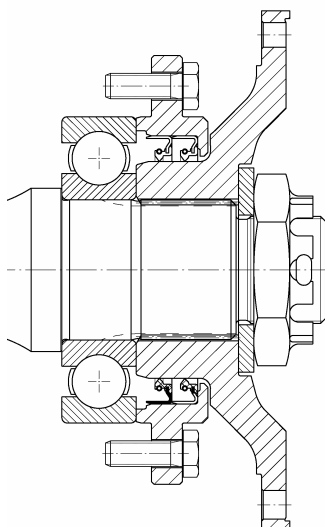
Picture 3. Earlier design of the output flange sealing.

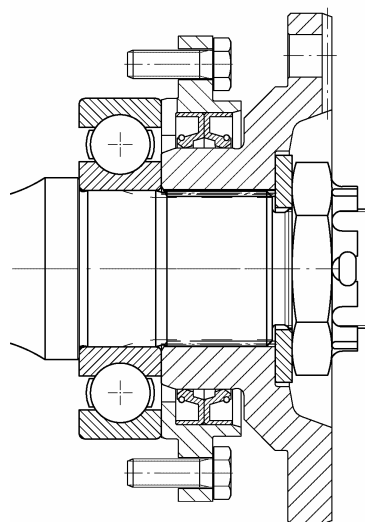
Picture 4. Current design of the output flange sealing.
