## **CONTROL AND REPAIR OF THE TIE ROD ARM MOUNTING IN 9 AND 10 TON DRIVE STEER FRONT AXLES**

This instruction concerns FSDP-09/10-S, FSTP-09/10-S and FSMP-10-S drive steer axles from serial number 10135 (January 2001) to serial number 163642 (August 2006).

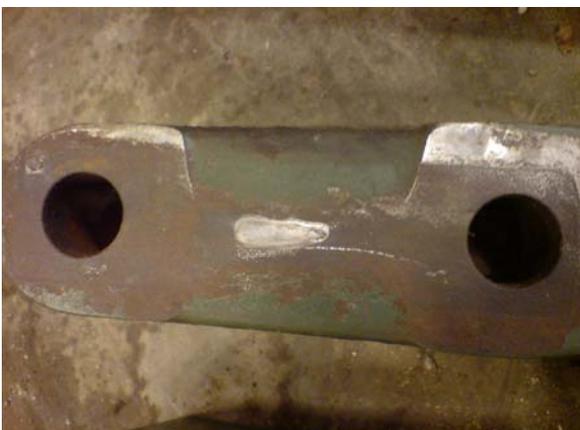
In the axles mentioned above there may appear fault in the mounting surfaces of the tie rod arms (LH 540-241-6610 and RH 540-241-6600). In the approx. 60 mm wide un-machined area there may have been left some spots which are higher than the machined surfaces (Picture 1.).

This may cause weakening in the tie rod arm mounting. That is why the axles between the above mentioned serial numbers have to be checked and repaired if needed.

Picture 1.  
Faulty mounting surface in tie rod arm

1. Unfasten the tie rod arm mounting bolts.
2. Remove all possible dirt and rust in the mounting surfaces of the tie rod arm and the steering knuckle.
3. Check the mounting surface straightness of the tie rod arm with a straightedge. The minimum gap is 0.1 mm. If the gap is smaller then there should be grinded away about 1 mm deep of the material In the approx. 60 mm wide area between the bolt holes (Picture 2.). Finally check again the straightness of the mounting planes. If the planes are not even or if there are any defects in the planes, the tie rod arm should be replaced by a new one or by tie rod arm refurbished by Sisu Axles.

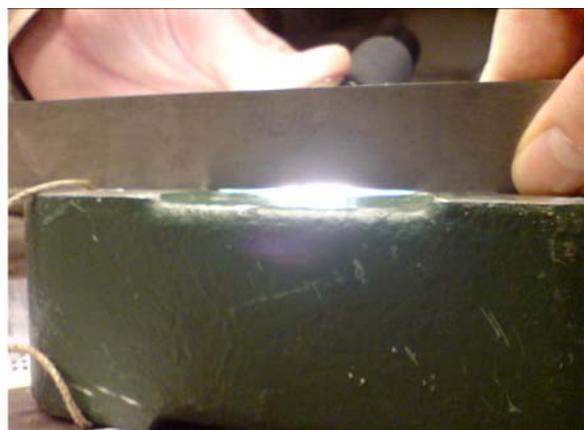
Picture 2.  
Checking the mounting surface
